Town of Arlington, Massachusetts

PART A – Executive Summary Self- Evaluation and Transition Plan

November 2019

Part A – Executive Summary

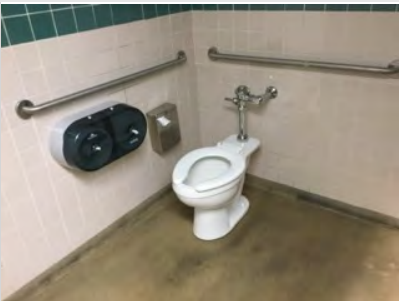
Door has malfunctioning self-closing hinge Flush control not on open side Non-compliant toilet paper dispenser	- - -	Repair hinge. Provide the flush control on the open side of the toilet (transfer side). Replace dispenser that does not allow continuous paper flow.	1	Labor 540	\$540
Additional Access

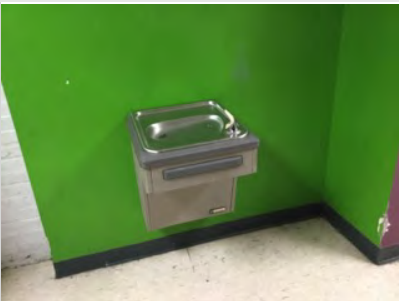
44	Hallway Near Technical Engineering Room	2		Drinking Fountains	Low

No drinking fountain provided for standing users	-	Provide an additional drinking fountain for standing users.	1	2014	\$2014
Additional Access												
42	Hallway Near 207	2		Drinking Fountains	Low

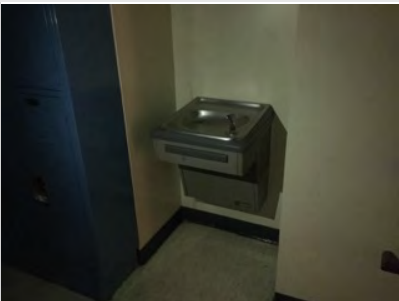
Clear floor space not provided No drinking fountain provided for standing users	30" -	It may be technically infeasible to enlarge this cove. Providing a Hi-Lo drinking fountain in this area.	1	2108	\$2108

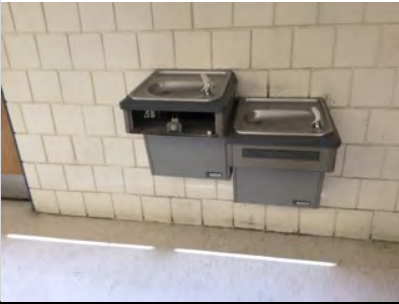
ID	Location	Floor	Room	Element	Type	Photo	Issues	Current Measure	Recommendations	Quantity	Price	Cost Estimation
Additional Access												
43	Hallway Near Media Center	2		Drinking Fountains	Hi-Lo

Operable parts malfunctioning Standing height fountain does not have cane protection	- -	Repair or replace drinking fountain to ensure operable parts function properly. Provide a cane-detectable barrier skirt under the high unit.	1	Labor 445	\$445
Additional Access												
45	Hallway Near Technical Engineering Room	2		Sink	Other

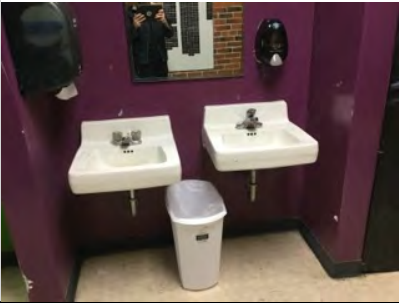
Clear floor space not provided at sink Exposed plumbing underneath sink	- -	Provide a 30" by 48" clear floor space positioned for a forward approach. Insulate or otherwise configure pipes at one sink min.	1	46	\$46
Access to Goods and Services												
46	LABBB Toilet Room	2		Signage	Designation

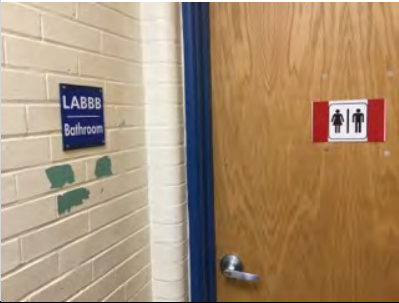
Raised characters not provided Braille not provided Sign not located on the latch side of the door International Symbol of Acc. not compliant	- - - -	Provide text with raised characters duplicated in braille. Locate sign at permanent rooms alongside the door on the latch side. Replace sign with a sign containing the International Symbol of Accessibility.	1	116	\$116

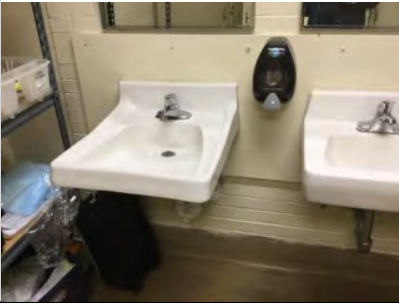
Toilet & Bathing Rooms												
47	LABBB Toilet Room	2		Lavatory	N/A

Mirror above lavatory w/reflective surface > 40"	45"	Lower mirror so that the bottom surface is at 40" max. above finished floor.	1	128	\$128

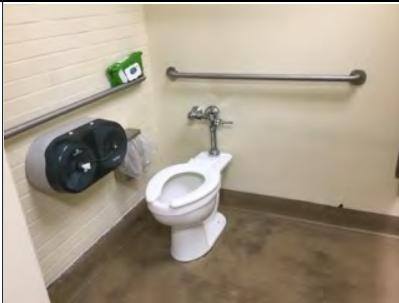
ID	Location	Floor	Room	Element	Type	Photo	Issues	Current Measure	Recommendations	Quantity	Price	Cost Estimation
48	LABBB Toilet Room	2		Toilet Compartment	Accessible Compartment

Non-compliant toilet paper dispenser	-	Relocate toilet paper so that it is 15" min high, located under the grab bar, and between 7" and 9" from the front of the toilet. Replace dispenser if it does not allow continuous paper flow.	1	353	\$353
Access to Goods and Services												
49	Lift to 7th Grade Wing	2		Platform Lift or LULA Elevator	Interior

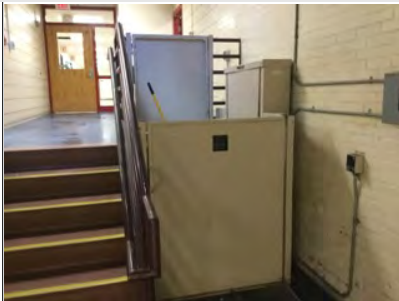
Not in operable working condition 36" x 48" clear floor space not provided (if end door)	- 33" x 60"	Ensure lift is maintained in operable working condition. Providing a 36" by 48" clear floor space might be technically infeasible.	1	Labor	\$0
Access to Goods and Services												
50	Media Center	2		Service Counter	N/A

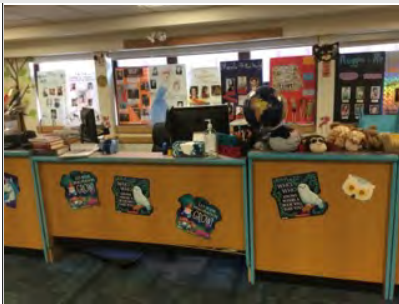
Counter > 36" high	38"	Provide a counter that is 36" max. above the ground or finished floor.	1	440	\$440

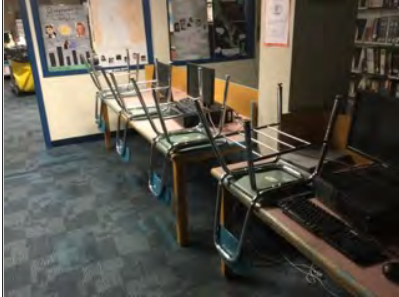
51	Media Center	2		Dining or Work Surfaces	Work Surface

At least one or 5% accessible tables not provided Knee or toe clearance not provided	- 25"	Provide at least one (1) accessible table with 27" min. knee clearance and 30" min. clear width. Ensure accessible work surfaces are well integrated with class seating plans.	1	350	
Additional Access												
52	Near Upper Gym	2		Drinking Fountains	Low

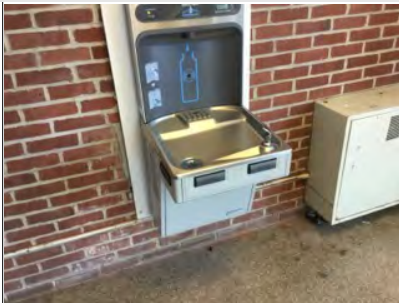
No drinking fountain provided for standing users	-	Provide an additional drinking fountain for standing users.	1	2014	\$2014

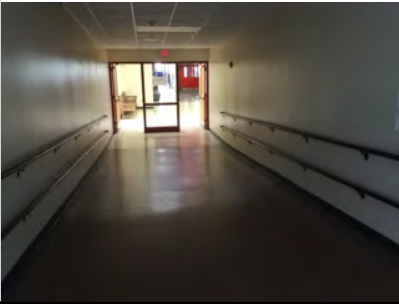
ID	Location	Floor	Room	Element	Type	Photo	Issues	Current Measure	Recommendations	Quantity	Price	Cost Estimation
Access to Goods and Services												
53	Route to Spanish Wing	2		Ramps	Interior

Handrails < 34" or > 38" above ramp surface.	33"	Alter so the handrails are 34"- 38" high above the floor.	1	Labor	\$0
Access to Goods and Services												
54	Route to Stage	2		Interior Access Route	N/A

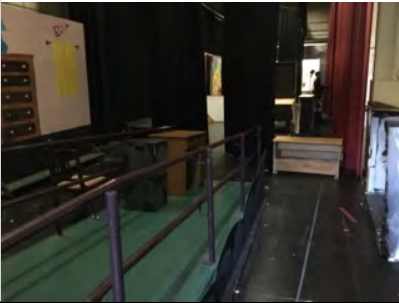
Obstructed by protruding objects	- -	Relocate performing arts supplies out of the way of the ramp and upper and lower landings.	1	Labor	\$0
Access to Goods and Services												
55	Study Rooms in Media Center	2		Signage	Designation

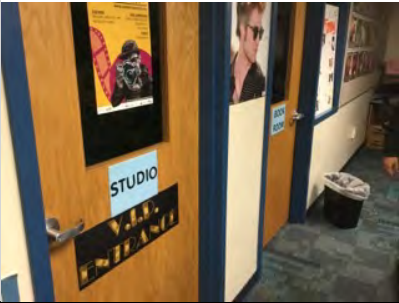
Raised characters not provided Braille not provided Sign not located on the latch side of the door	- - -	Provide text with raised characters duplicated in braille. Locate sign at permanent rooms alongside the door on the latch side.	3	116	\$348
Best Practice

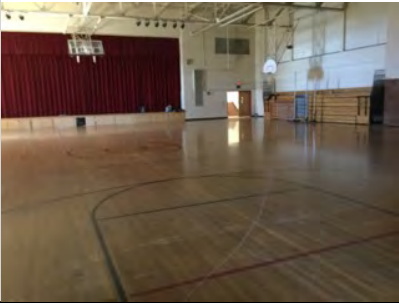
56	Upper Gym	2

Best Practice: Consider providing an integrated means of accessing the stage from the upper gym. Current route is long and not easy to access.	1	-	\$0

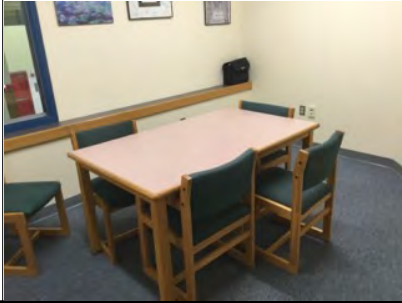
ID	Location	Floor	Room	Element	Type	Photo	Issues	Current Measure	Recommendations	Quantity	Price	Cost Estimation
Access to Goods and Services												
57	Upper Office Conference Room	2		Dining or Work Surfaces	Work Surface

Knee or toe clearance not provided	26"	Provide at least 1 work surface with 27" min. knee and toe clearance.	1	350	\$350
Access to Goods and Services												
58	Teacher's Lounge	2	201	Signage	Designation

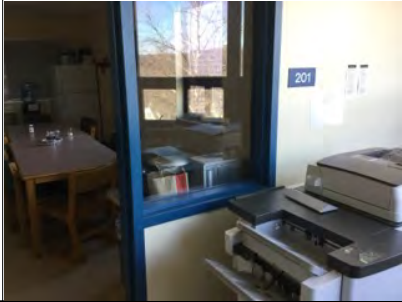
Sign lacks clear floor space	-	Ensure that sign is located on the latch side of the door. Signs containing tactile characters should be located so that a clear floor space of 18 inches by 18 inches min., centered on the tactile characters is provided. Relocate bookshelf and sign.	1	Labor	\$0
Access to Goods and Services												
59	Science Classroom	2	202	Dining or Work Surfaces	Work Surface

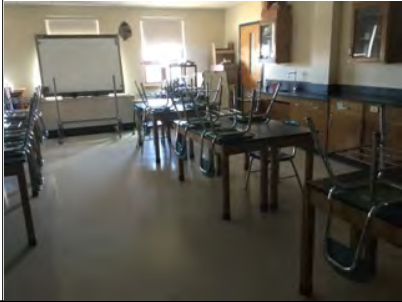
At least one or 5% accessible tables not provided	-	Provide at least one (1) accessible desk with 27" min. knee clearance and 30" min. clear width. Ensure accessible work surfaces are well integrated with class seating plans.	1	350	\$350

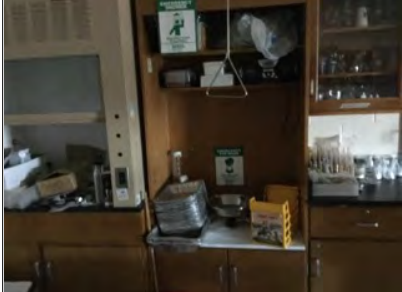
60	Science Classroom	2	202	Laboratory	Other

Emergency shower out of reach range At least one (or 5%) acc. fume hood not provided	- 60"	Provide an accessible fume hood with a work surface no higher than 34" above the finished floor, knee and toe clearance for a forward approach and controls that are located within reach range. Provide one accessible emergency shower or lower the shower pull to 48" max. (Cost estimate based on a new fume hood and lowering the shower pull.)	1	1751 Labor	\$1751

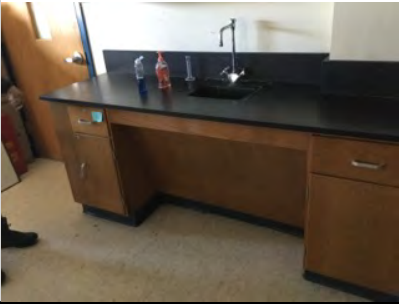
ID	Location	Floor	Room	Element	Type	Photo	Issues	Current Measure	Recommendations	Quantity	Price	Cost Estimation
Additional Access												
61	Science Classroom	2	202	Sink	Lab

Toe and knee clearances not provided Non-compliant faucets	- -	Ensure there is a 27" knee clearance positioned for a forward approach. Install faucets that do not require tight grasping, pinching, or twisting of the wrist.	1	1336	\$1336
Access to Goods and Services												
62	Spanish Classroom	2	205	Dining or Work Surfaces	Work Surface

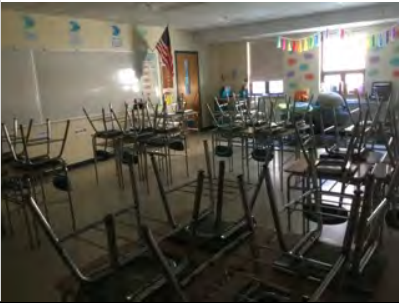
At least one or 5% accessible tables not provided	-	Provide at least one (1) accessible desk with 27" min. knee clearance and 30" min. clear width. Ensure accessible work surfaces are well integrated with class seating plans.	1	350	\$350
Access to Goods and Services												
63	English Classroom	2	209	Dining or Work Surfaces	Work Surface

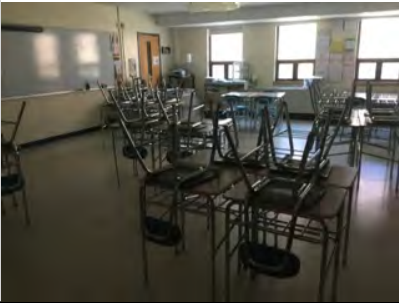
At least one or 5% accessible tables not provided	-	Provide at least one (1) accessible desk with 27" min. knee clearance and 30" min. clear width. Ensure accessible work surfaces are well integrated with class seating plans.	1	350	\$350

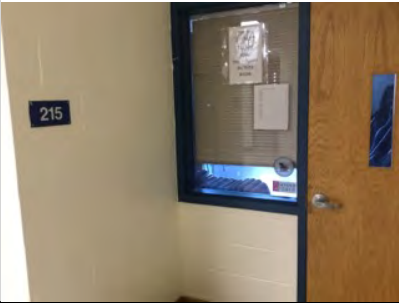
Access to Goods and Services												
64	Music Room	2	215	Signage	Designation

Sign not located on the latch side of the door	-	Locate sign at permanent rooms alongside the door on the latch side.	1	Labor	\$0

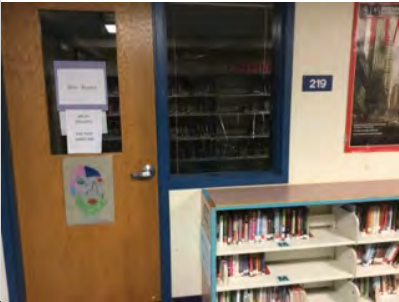
ID	Location	Floor	Room	Element	Type	Photo	Issues	Current Measure	Recommendations	Quantity	Price	Cost Estimation
Access to Goods and Services												
65	Office in Media Center	2	219	Signage	Designation

Sign lacks clear floor space	-	Ensure that sign is located on the latch side of the door. Signs containing tactile characters should be located so that a clear floor space of 18 inches by 18 inches min., centered on the tactile characters is provided. Relocate bookshelf and sign.	1	Labor	\$0
Access to Goods and Services												
66	Classroom	2	220	Signage	Designation

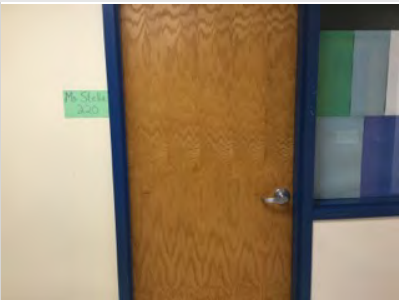
Raised characters not provided Braille not provided Sign not located on the latch side of the door	- - -	Provide text with raised characters duplicated in braille. Locate sign at permanent rooms alongside the door on the latch side.	1	116	\$116
Access to Goods and Services												
67	Classroom	2	222	Signage	Designation

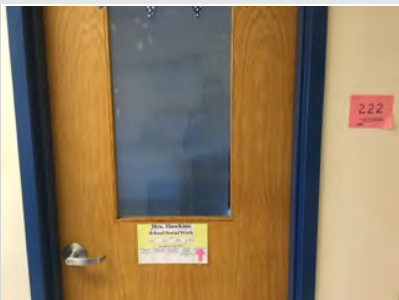
Raised characters not provided Braille not provided Sign not located on the latch side of the door Text size non-compliant	- - - -	Provide text with raised characters duplicated in braille. Locate sign at permanent rooms alongside the door on the latch side. Ensure that character size complies with the Character Height Table 703.5.5 in the ADA 2010 Standards.	1	116	\$116

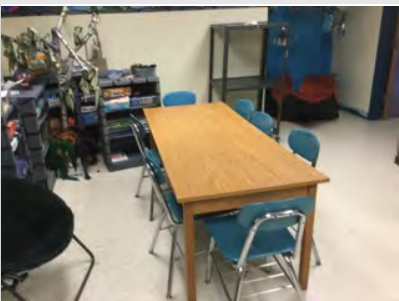
Access to Goods and Services												
68	After School Room	2	229	Dining or Work Surfaces	Work Surface

Knee or toe clearance not provided	23"	Provide at least 1 work surface with 27" min. knee and toe clearance.	1	350	\$350

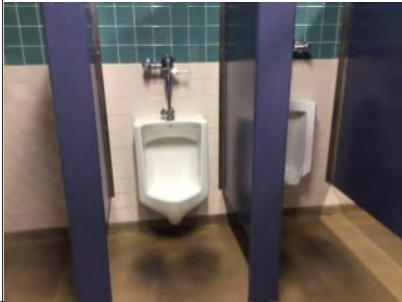
ID	Location	Floor	Room	Element	Type	Photo	Issues	Current Measure	Recommendations	Quantity	Price	Cost Estimation
Toilet & Bathing Rooms												
69	Boys' Toilet Room Near 314	3		Urinal	N/A

Urinal recessed > 24" has > 36" clear width	31"	If urinal is recessed greater than 24" ensure there is a clear width of 36". Reconfigure partition at accessible urinal.	1	256	\$256
Toilet & Bathing Rooms												
73	Boys' Toilet Room Near 340	3		Toilet Compartment	Accessible Compartment

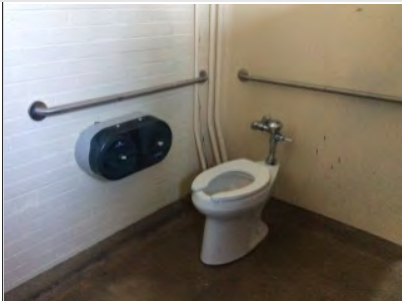
Non-compliant toilet paper dispenser Centerline < or > 18" (MAAB)	- 19"	Replace dispenser that does not allow continuous paper flow. Toilet centerline is not entirely compliant, but is usable.	1	353	\$353
74	Boys' Toilet Room Near 340	3		Lavatory	N/A

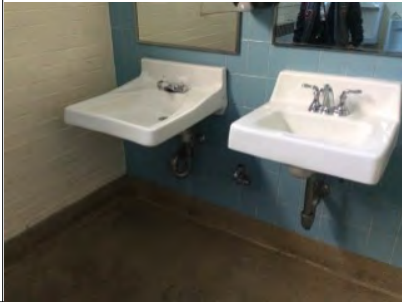
Plumbing underneath is exposed	-	Insulate or otherwise configure pipes to prevent contact, for at least one lavatory.	1	46	\$46
Toilet & Bathing Rooms

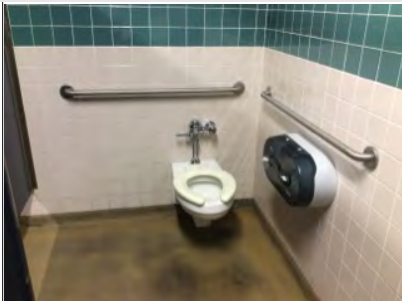
70	Boys' Toilet Room Near 314	3		Toilet Compartment	Accessible Compartment

Non-compliant toilet paper dispenser Centerline < or > 18" (MAAB)	- 17"	Replace dispenser that does not allow continuous paper flow. Toilet centerline does not comply with 521 CMR but does comply with the ADA. It is not entirely compliant, but usable.	1	353	\$353

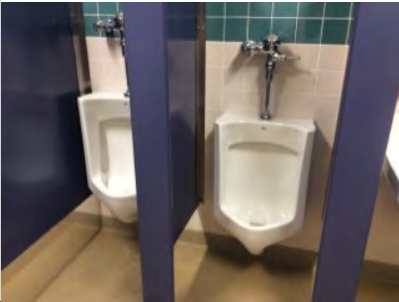
ID	Location	Floor	Room	Element	Type	Photo	Issues	Current Measure	Recommendations	Quantity	Price	Cost Estimation
Toilet & Bathing Rooms												
71	Boys' Toilet Room Near 321	3		Urinal	N/A

Urinal recessed > 24" deep has > 36" clear width	32"	Reconfigure partition to allow for 36" clear width min.	1	256	\$256
72	Boys' Toilet Room Near 321	3		Toilet Compartment	Accessible Compartment

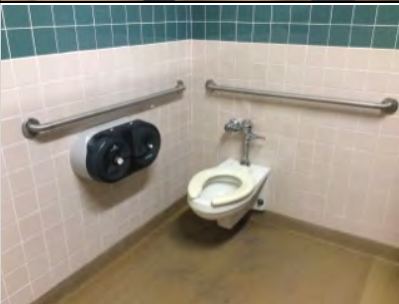
Door has malfunctioning self-closing hinge Non-compliant toilet paper dispenser Centerline < or > 18" (MAAB)	- - 19"	Repair hinge. Relocate toilet paper so that it is 15" min high, located under the grab bar, and between 7" and 9" from the front of the toilet. Replace dispenser if it does not allow continuous paper flow. Toilet centerline is not entirely compliant, but is usable.	1	Labor 353	\$353
Toilet & Bathing Rooms												
75	Boys' Toilet Room Near 340	3		Dispensers	Paper Towel Dispenser

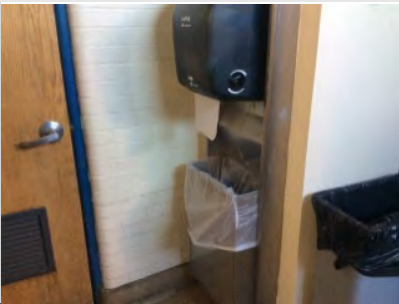
Dispenser not operable with a closed fist	-	Provide a dispenser that can be operable with one hand and not require tight grasping, pinching, or twisting of the wrist. (Cost estimate based on installation of a new compliant dispenser.)	1	470	\$470

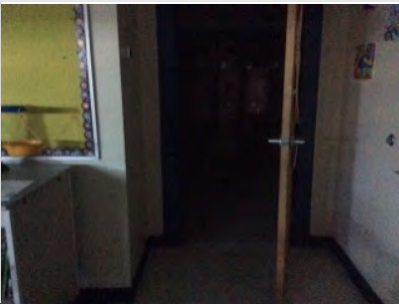
Access to Goods and Services												
76	Classroom Near 334	3	-	Doors, Doorways, & Gates	Classroom

Maneuvering clearance not provided at recess > 8"	9"	Install an automatic door opener.	1	1530	\$1530

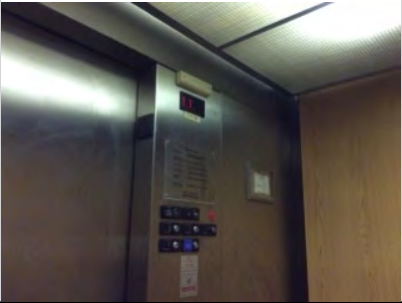
Best Practice: Recommend redesigning button designation signage to have more intuitive floor designations. Current design does not reflect the generally recognized floor order; LL is floor 2, 1 is floor 3, 2 is floor 4, etc.	1	-	\$0
Access to Goods and Services												
79	Elevator Near 321	3		Elevator	Interior

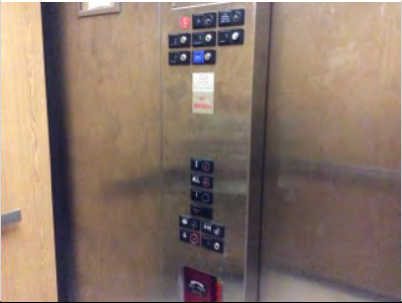
Elevator doors remain fully open < 3 seconds	- -	Adjust closer on elevator door so that doors remain open for at least 3 seconds.	1	Labor	\$0
Toilet & Bathing Rooms												
80	Girl's Toilet Room Near 321	3		Lavatory	N/A

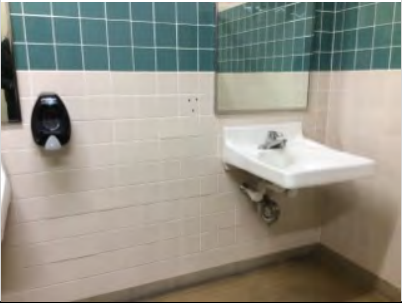
Plumbing underneath is exposed	-	Insulate or otherwise configure pipes to prevent contact at lavatory.	1	46	\$46

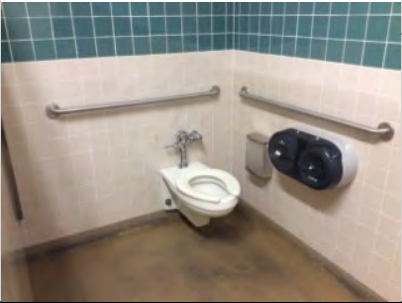
Non-compliant toilet paper dispenser	-	Replace dispenser that does not allow continuous paper flow.	1	353	\$353
Toilet & Bathing Rooms												
83	Girls' Toilet Room Near 329	3		Toilet Compartment	Accessible Compartment

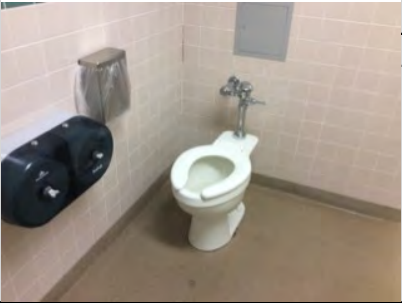
Grab bars not provided Non-compliant toilet paper dispenser Centerline < or > 18" (MAAB)	- - 17"	Provide one grab bar on the side wall of the water closet and one on the rear wall. Replace dispenser that does not allow continuous paper flow. Toilet centerline does not comply with 521 CMR but does comply with the ADA. It is not entirely compliant, but usable.	1	2216	\$2216

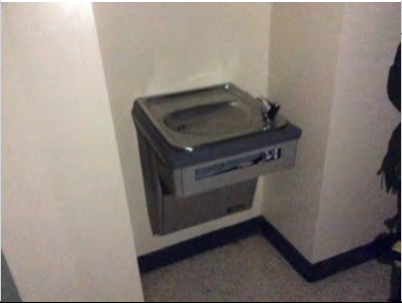
Additional Access												
84	Hallway Near 314	3		Drinking Fountains	Low

No drinking fountain provided for standing users	-	Provide an additional drinking fountain for standing users.	1	2014	\$2014

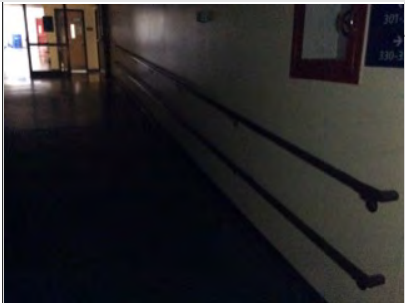
Handrails < 34" or > 38" above ramp surface.	32"	Alter so the handrails are 34"- 38" high above the floor.	1	Labor	\$0
Access to Goods and Services												
87	Main Elevator	3		Elevator	Interior

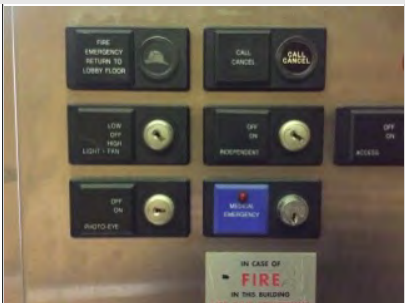
Raised characters / braille not provided on cabin controls	-	Ensure that raised character and braille designations are placed immediately to the left of the control button to which the designations apply.	1	240	\$240
Access to Goods and Services												
88	Science Classroom	3	302	Dining or Work Surfaces	Work Surface

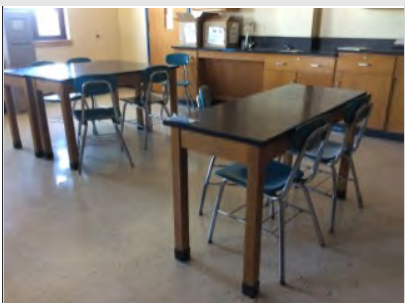
At least one or 5% accessible tables not provided	-	Provide at least one (1) accessible table with 27" min. knee clearance and 30" min. clear width. Ensure accessible work surfaces are well integrated with class seating plans.	1	350	\$350

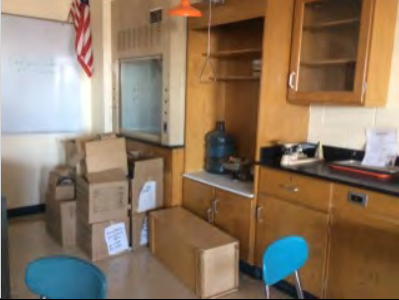
ID	Location	Floor	Room	Element	Type	Photo	Issues	Current Measure	Recommendations	Quantity	Price	Cost Estimation
89	Science Classroom	3	302	Laboratory	Other

At least one (or 5%) acc. fume hood not provided Emergency shower out of reach range	- 59"	Provide an accessible fume hood with a work surface no higher than 34" above the finished floor, knee and toe clearance for a forward approach and controls that are located within reach range. Provide one accessible emergency shower or lower the shower pull to 48" max. (Cost estimate based on a new fume hood and lowering the shower pull.)	1	1751 Labor	\$1751
Additional Access												
90	Science Classroom	3	302	Sink	Lab

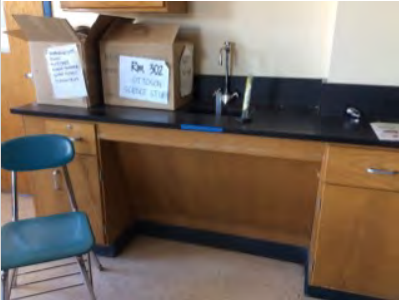
Non-compliant faucets	-	Install faucets that do not require tight grasping, pinching, or twisting of the wrist.	1	493	\$493
Access to Goods and Services												
91	Science Classroom	3	308	Laboratory	Other

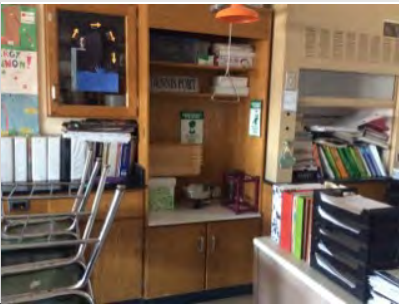
At least one (or 5%) acc. fume hood not provided Emergency shower out of reach range	- 59"	Provide an accessible fume hood with a work surface no higher than 34" above the finished floor, knee and toe clearance for a forward approach and controls that are located within reach range. Provide one accessible emergency shower or lower the shower pull to 48" max. (Cost estimate based on a new fume hood and lowering the shower pull.)	1	1751 Labor	\$1751

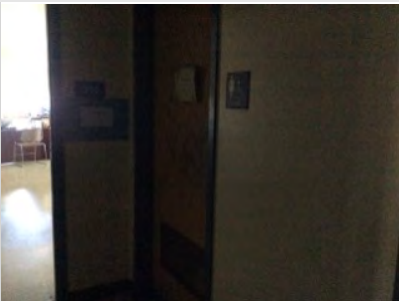
Access to Goods and Services												
92	Girls' Toilet Room Near 314	3	314	Doors, Doorways, & Gates	Toilet Room

Door requires > 5 lbs. of force to open	15 lbs.	Adjust closers so doors do not require more than 5 pounds of force to open.	1	Labor	\$0

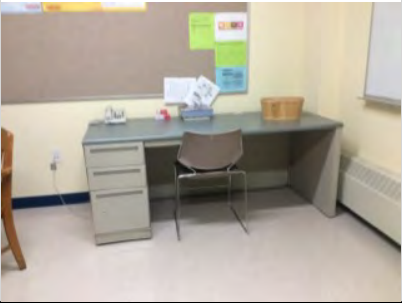
At least one or 5% accessible tables not provided	-	Provide at least one (1) accessible desk with 27" min. knee clearance and 30" min. clear width.	1	550	\$550
Access to Goods and Services												
94	Art Room	3	326	Signage	Designation

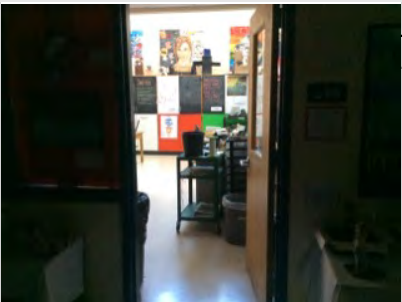
Sign not located on the latch side of the door Non glare finish and contrast not provided	- -	Locate sign at permanent rooms alongside the door on the latch side. Provide signs with a non-glare finish with characters that have a high contrast to the background.	1	Labor 116	\$116
95	Art Room	3	326	Interior Access Route	N/A

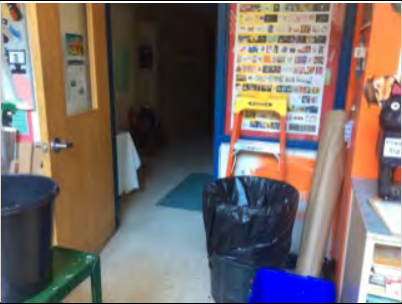
Route < 36" wide	-	Relocate trash bin to ensure that a clear width of 36" min. is maintained at the route.	1	Labor	\$0

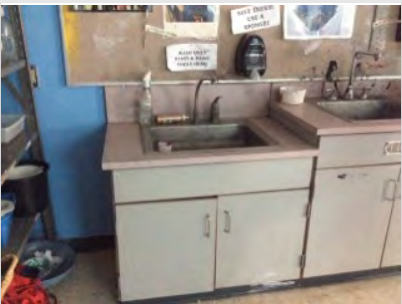
Additional Access												
96	Art Room	3	326	Sink	Classroom

Toe and knee clearances not provided	-	Ensure there is a 27" knee clearance positioned for a forward approach. Provide bracing and remove base cabinet.	1	843	\$843
97	Art Room	3	326	Sink	Classroom

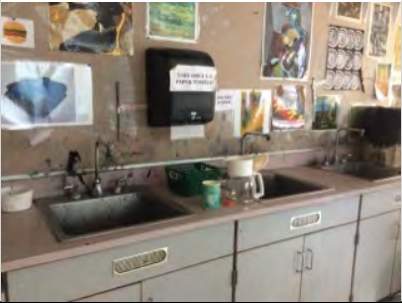
Toe and knee clearances not provided	-	Ensure there is a 27" knee clearance positioned for a forward approach. Provide bracing and remove base cabinet.	1	843	\$843

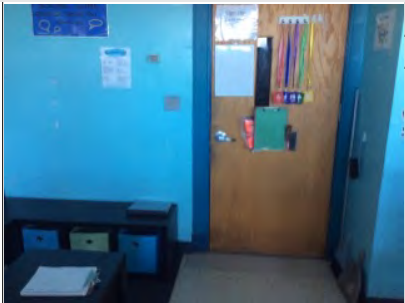
Maneuvering clearance(s) not provided Mat not securely attached	- -	Relocate the storage out out of the door maneuvering clearance. Secure the mat.	1	Labor	\$0
Access to Goods and Services												
100	Classroom	3	333	Dining or Work Surfaces	Work Surface

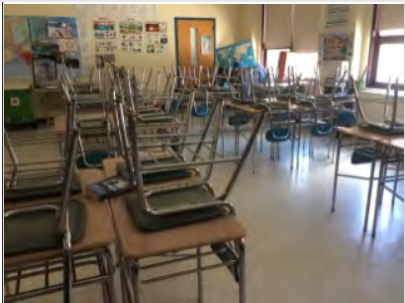
At least one or 5% accessible tables not provided	-	Provide at least one (1) accessible desk with 27" min. knee clearance and 30" min. clear width. Ensure accessible work surfaces are well integrated with class seating plans.	1	350	\$350

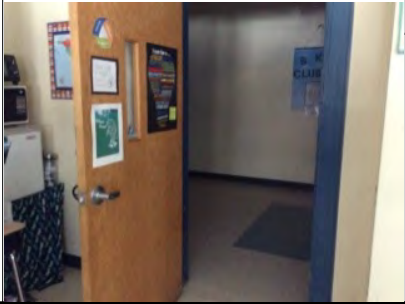
101	Classroom	3	333	Doors, Doorways, & Gates	Classroom

Maneuvering clearance not provided at recess > 8"	11"	Install an automatic door opener.	1	1530	\$1530

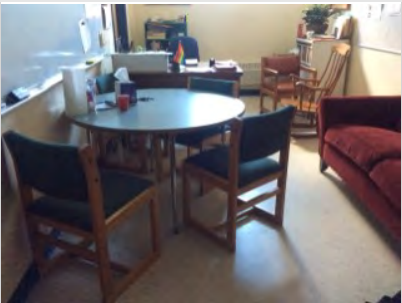
Route < 36" wide	28"	Relocate furniture to provide a clear width of 36" min.	1	Labor	\$0
Access to Goods and Services												
104	Classroom	3	355	Interior Access Route	N/A

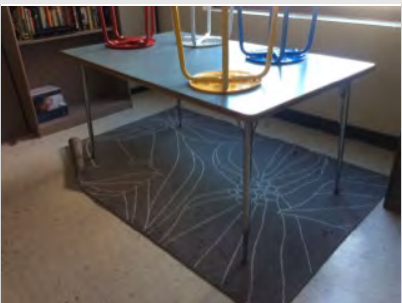
Surface not stable, firm, and slip-resistant	-	Secure the mat.	1	Labor	\$0
Access to Goods and Services												
105	Boy's Toilet Room Near 447	4		Doors, Doorways, & Gates	Toilet Room

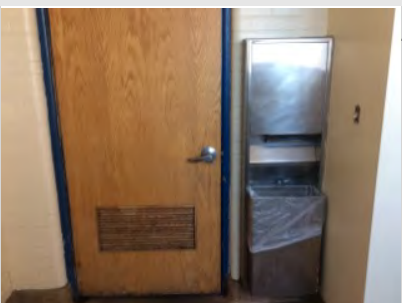
Maneuvering clearance(s) not provided	-	Remove or relocate the trash bin away from the door maneuvering clearance.	1	353	\$353

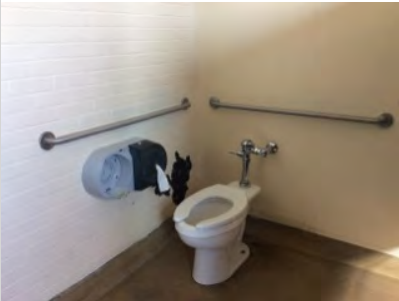
Door has malfunctioning self-closing hinge Flush control not on open side Non-compliant toilet paper dispenser	- - -	Repair hinge. Provide the flush control on the open side of the toilet (transfer side). Replace dispenser that does not allow continuous paper flow.	1	Labor 540	\$540
Access to Goods and Services												
107	Girl's Toilet Room Near 447	4		Signage	Designation

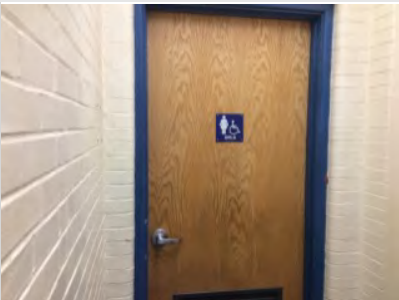
Sign not located on the latch side of the door	-	Locate sign at permanent rooms alongside the door on the latch side. Where there is no wall space at the latch side of the door, signs should be located on the nearest adjacent wall.	1	Labor	\$0
Toilet & Bathing Rooms												
108	Girl's Toilet Room Near 447	4		Lavatory	N/A

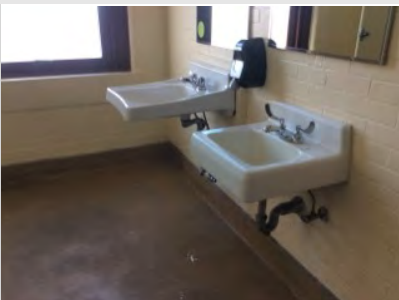
Plumbing underneath is exposed	-	Insulate or otherwise configure pipes to prevent contact, for at least one lavatory.	1	46	\$46

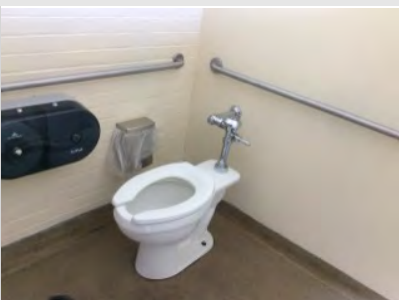
Toilet & Bathing Rooms												
109	Girls' Toilet Room Near 447	4		Toilet Compartment	Accessible Compartment

Door has malfunctioning self-closing hinge Non-compliant toilet paper dispenser Centerline < or > 18" (MAAB)	- - 16"	Repair hinge. Replace dispenser that does not allow continuous paper flow. Toilet centerline does not comply with 521 CMR but does comply with the ADA. It is not entirely compliant, but usable.	1	Labor 353	\$353

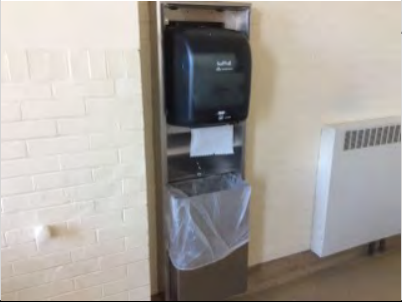
Not operable with a closed fist	-	Provide a dispenser that can be operable with one hand and not require tight grasping, pinching, or twisting of the wrist. (Cost estimate based on installation of a new compliant dispenser.)	1	470	\$470
Access to Goods and Services												
111	Main Elevator	4		Elevator	Interior

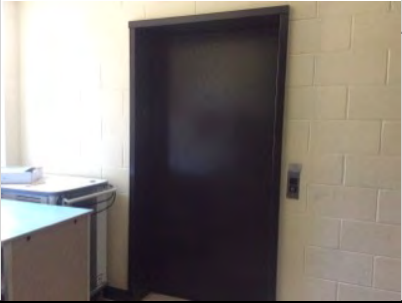
Hoistway signs not on both jambs	-	Provide hoistway signs on both sides of jambs on all four (4) floors.	8	48	\$384
Best Practice												
112	Stairs Near 440, (Same at All)	4			Stairs

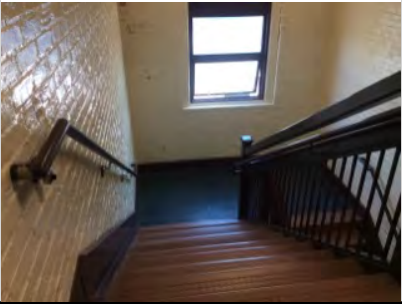
Best Practice: Consider renovating stairs to have accessible handrails with extensions. Consider adding color-contrasting strips at each stair tread to improve access for people who are blind or low-vision.	1	-	\$0

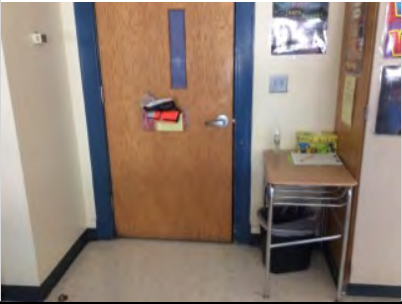
Access to Goods and Services												
113	Classroom	4	443	Doors, Doorways, & Gates	Classroom

Maneuvering clearance(s) not provided	-	Relocate the desk out out of the door maneuvering clearance.	1	Labor	\$0

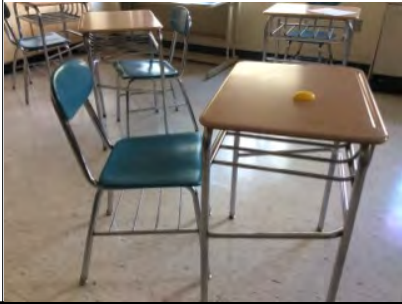
At least one or 5% accessible tables not provided	-	Provide at least one (1) accessible desk with 27" min. knee clearance and 30" min. clear width. Ensure accessible work surfaces are well integrated with class seating plans.	1	350	\$350
Additional Access												
115	Classroom	4	447	Sink	Classroom

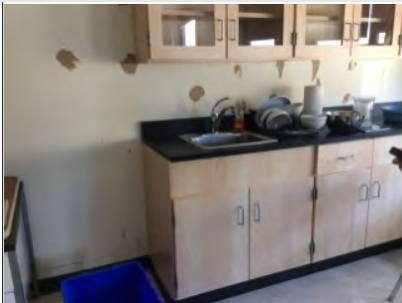
Toe and knee clearances not provided	-	Ensure there is a 27" knee clearance positioned for a forward approach. Provide bracing and remove base cabinet.	1	843	\$843
Access to Goods and Services												
116	Classroom	4	456	Dining or Work Surfaces	Work Surface

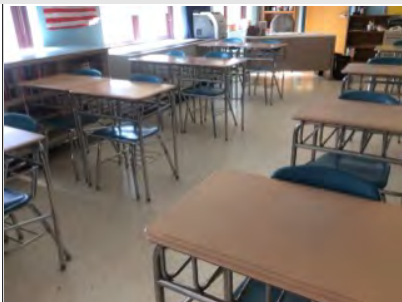
At least one or 5% accessible tables not provided	-	Provide at least one (1) accessible desk with 27" min. knee clearance and 30" min. clear width. Ensure accessible work surfaces are well integrated with class seating plans.	1	350	\$350

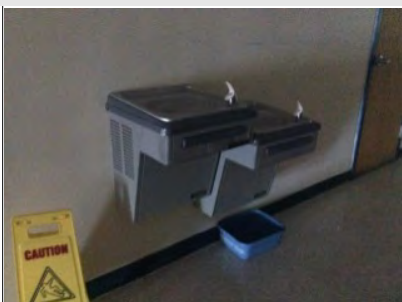
Additional Access												
117	Classroom	4	456	Drinking Fountains	Hi-Lo

Clear floor space not provided Operable parts malfunctioning Standing height fountain does not have cane protection	- - -	Repair or replace drinking fountain to ensure operable parts function properly. When repaired, remove the drip tray underneath the low fountain. Provide a cane-detectable barrier skirt under the high unit.	1	Labor 445	\$445

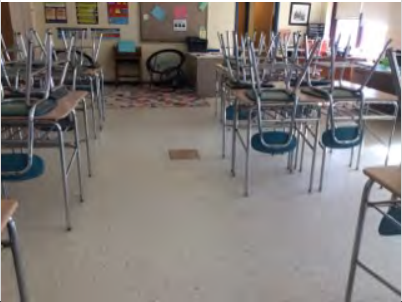
At least one or 5% accessible tables not provided	-	Provide at least one (1) accessible desk with 27" min. knee clearance and 30" min. clear width. Ensure accessible work surfaces are well integrated with class seating plans.	1	350	\$350
119	Classroom	4	458	Interior Access Route	N/A

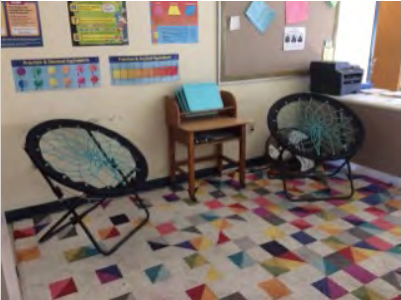
Surface not stable, firm, and slip-resistant	-	Secure the mat.	1	Labor	\$0
Approach and Entrance												
120	Community Garden	Ext.		Exterior Access Route	Exterior

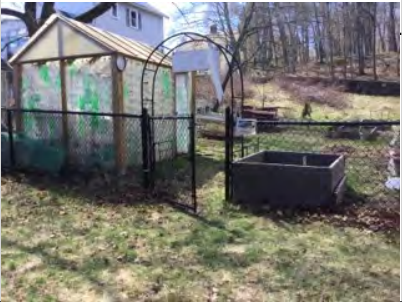
Accessible route not provided		Ensure an accessible route is provided. (Cost estimate based on 225 ft. long stone dust route to provide accessible routes to the community garden from exit 13, and inside the community garden.)	1	5126	\$5126

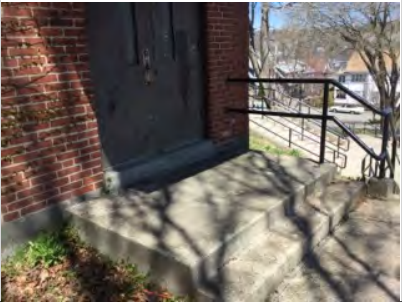
Best Practice												
121	Exit 10	Ext.			Stairs

Best Practice: Recommend renovating exterior stairs to have accessible handrails on both sides.	1	-	\$0

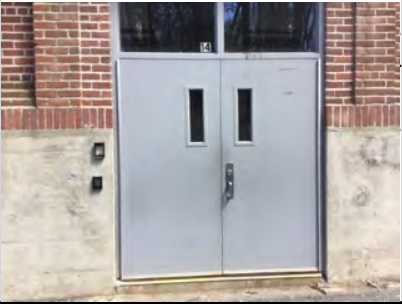
Emergency exit not on an accessible route Directional sign to accessible emergency exit not provided Tactile exit sign not provided Threshold > 1/2" high	- - - 6"	On the interior, provide a directional sign indicating the location of the nearest emergency exit. On the interior, provide a tactile exit sign with raised characters and braille at exit doors. Mount the sign between 48" - 60" above the finished floor on the latch side of the door.	2	116	\$232
Approach and Entrance												
123	Exit 3	Ext.		Emergency Exit	N/A

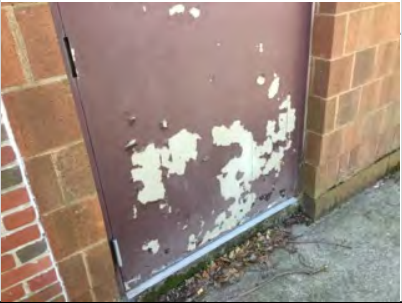
Threshold > 1/2" high	6"	Alter threshold to be 1/2" high max. Build a 6' by 6' concrete platform at the door and reslope the ramp leading to the street. (Cost estimate for a platform and resloping ramp to 50' ramp to the street to ensure that the running slope does not exceed 1:12 slope.)	1	2552	\$2552

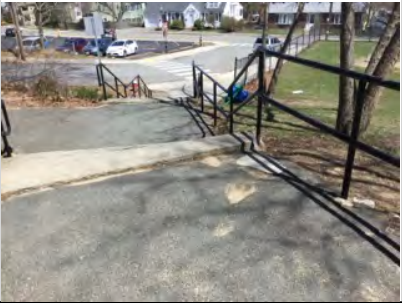
Best Practice												
124	Exit to Stairs From Blue Gym	Ext.

Level changes > 1/4"	2"	Best Practice: Although this is not an accessible route, consider renovating transition point between concrete and asphalt for safety. Alter the change in level to be 1/4" high max.	1	-	\$0
Toilet & Bathing Rooms												
125	Near Softball Field	Ext.		Portable Toilet	N/A

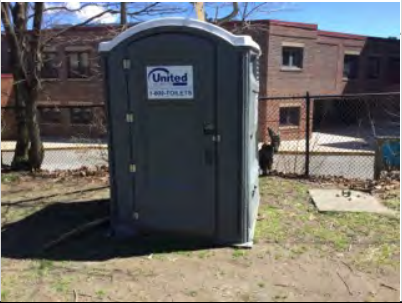
Not located on an accessible route	-	Locate portable toilet on an accessible route.	1	Labor	\$0

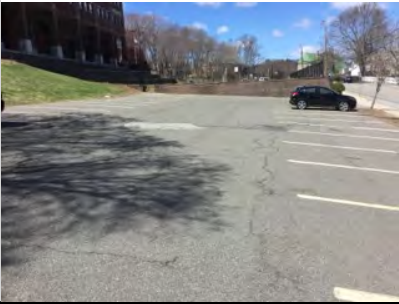
Total # of parking Total # of designated accessible parking spaces Total # of designated van accessible spaces	24 0 0	Provide at least one (1) van-accessible parking space.	1	1850	\$1850
Approach and Entrance												
127	Rear Parking Lot	Ext.		Exterior Access Route	Exterior

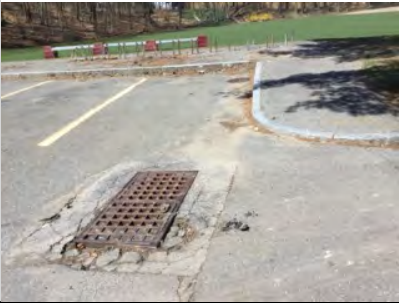
Surface openings > 1/2" Route not maintained in operable working condition	2" -	Replace or reposition so that openings are 1/2" max. and the long opening dimension is perpendicular to the dominant direction of travel. Ensure the accessible route is maintained in operable working condition. (Cost estimate based on new grates and repair of surrounding asphalt.)	1	1778	\$1778
Access to Goods and Services

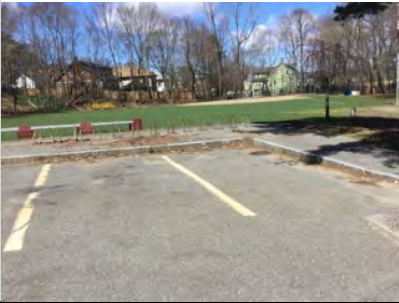
128	Rear Parking Lot	Ext.		Operable Parts	Bike Rack

Element not on an accessible route	-	Ensure bike rack is located on an accessible route. Provide a curb cut.	1	2800	\$2800
Access to Goods and Services												
129	Route From Exit 3	Ext.		Ramps	Exterior

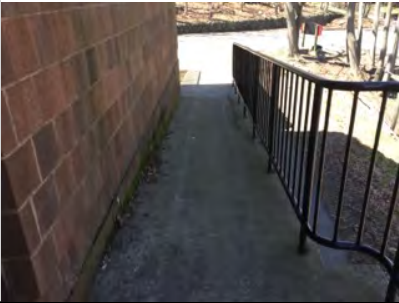
Handrails not provided at both sides if rise is > 6" No lower handrail 18"-20" high provided	-	Provide handrails on both sides. Provide a lower handrail between 18" to 20" high.	1	7000	\$7000

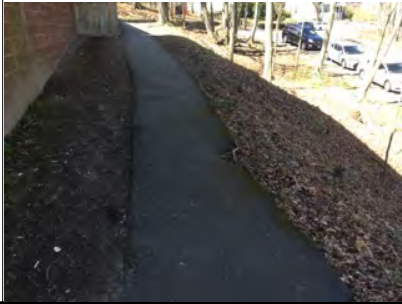
Best Practice: Recommend installing edge protection or other retaining features along exterior walkways to guard against falls.	1	-	\$0
Approach and Entrance												
131	School Parking on Southwest	Ext.		Off-Street Parking Lot or Garage	Visitor

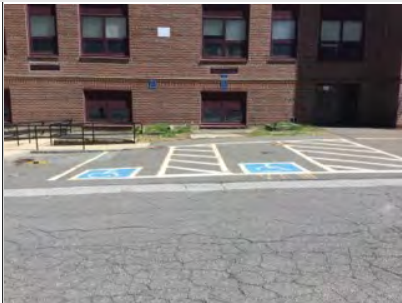
Vehicle space < 96" wide at car space Running or cross slope at access aisle > 1:50 (2.00%) Sign does not have the designation "Van Accessible"	90" 5.5% -	Ensure that the car-accessible parking space is at least 96" wide. Reduce running or cross slope at accessible spaces and access aisles to be no steeper than 1:50 (2.00%). Add the designation "Van Accessible" to the sign located at the van accessible space.	1	4150	\$4150
Play and Sport Areas

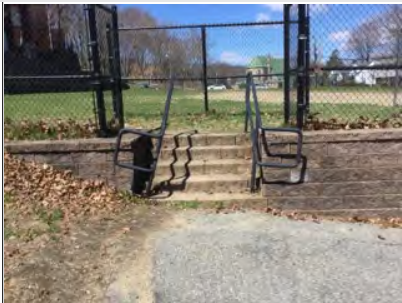
132	Soccer Field Entrance	Ext.		Field

Field not connected to an accessible route		Ensure soccer field is connected to an accessible route. Consider removal of a portion of the fence and installing a gate where the entry to the field is level on the opposite side of the field. (Cost to be determined.) After an accessible entrance is created, provide a sign with the International Symbol of Accessibility (ISA) at the accessible entrance.	1	TBD 173	\$173
Approach and Entrance												
133	Soccer Field Entrance	Ext.		Entrance	Stairs

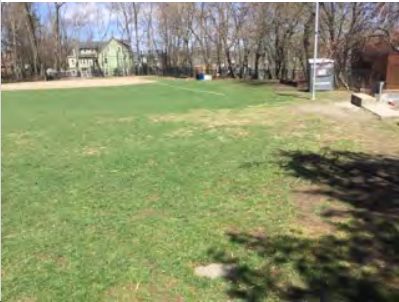
Field not connected to an accessible route	-	Ensure softball field is connected to an accessible route. (Cost estimate based on the installation of 320 linear ft. of asphalt.)	1	11093	\$11093
135	Softball Field	Ext.		Field	Softball

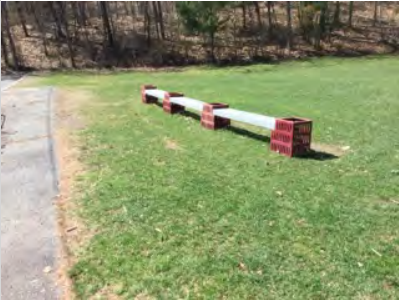
Accessible spaces not provided at sidelines seating	-	Provide a 36" x 48" clear floor space at sidelines seating. (Cost estimate based on installation of 150 long asphalt route to create a compliant route with clear floor space.)	1	5200	\$5200
Best Practice												
136	Softball Field Entrance	Ext.			Stairs

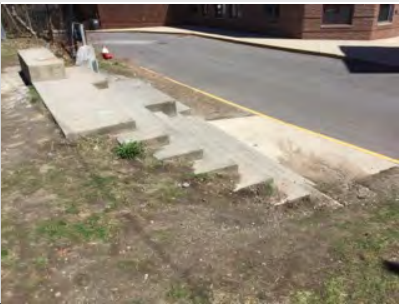
Best Practice: Recommend renovating exterior stairs to have accessible handrails.	1	-	\$0
Approach and Entrance												
137	Walkway by Stairs on the Northeast Side on Acton Street Leading to the Soccer Field	Ext.		Exterior Access Route	Walkway

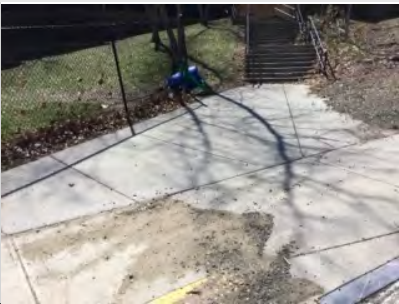
Cross slope > 1:50 (2.00%)	4%	Reduce cross slope to be no steeper than 1:50 (2.00%). (Cost estimate based on renovating cross slope for a 30' long concrete area.)	1	900	\$900

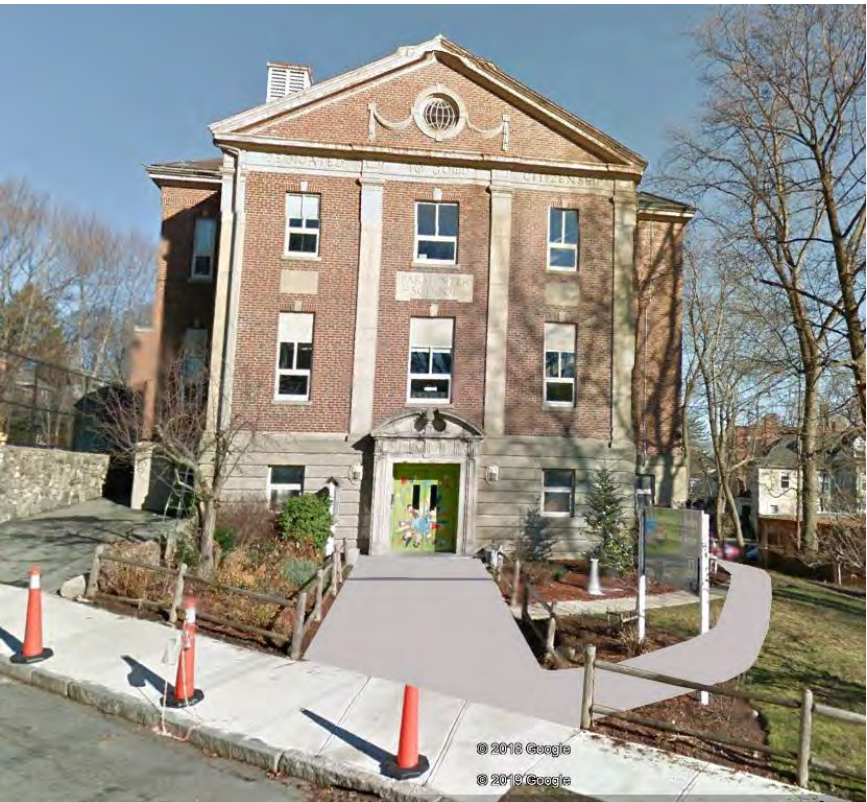
There is no accessible entrance to the either of the two areas of this building. The west entrance to the Arlington Children’s Center has an excessive slope. The front entrance to the International School has stairs. Re-sloping the main entrance to

provide a five-foot deep level landing and a sloped walkway that does not exceed 5% (1:20) is recommended. With this change the egress route from the east side will also need to be re-routed.

Image shows accessible route to the entrance and east side.

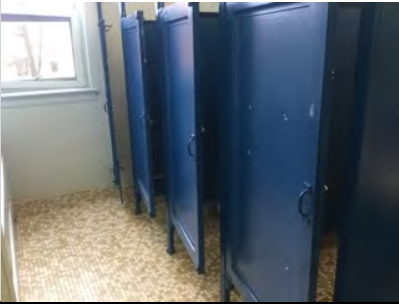
Accessible plumbing fixtures or stalls not provided		Provide one accessible wheelchair compartment in one of the two all-gender toilet rooms by Classroom 3.	1	3091	\$3091
Access to Goods and Services												
2	All-Gender Toilet Rooms Near Classroom 3	1		Signage	Designation

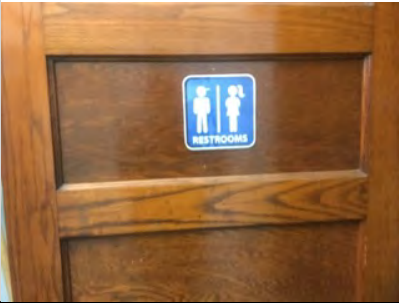
Raised characters not provided Braille not provided Sign not located on the latch side of the door International Symbol of Acc. not compliant		For both toilet rooms, provide text with raised characters duplicated in braille and locate the sign alongside the door on the latch side. Ensure that the International Symbol of Accessibility is provided on the toilet room that is brought into compliance.	2	116 Labor	\$232

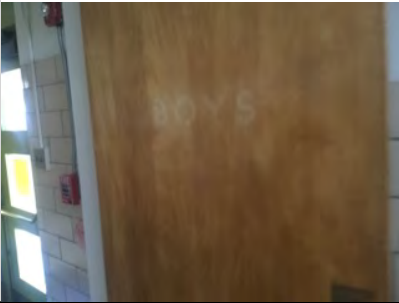
Access to Goods and Services												
3	Boys' Toilet Room	1		Signage	Designation

Not provided Raised characters not provided Braille not provided Sign not located on the latch side of the door International Symbol of Acc. not compliant		Provide a designation sign with text with raised characters duplicated in braille. Locate sign at permanent rooms alongside the door on the latch side. After the toilet room is brought into compliance, provide a sign containing the International Symbol of Accessibility.	1	Labor 116	\$116
Toilet & Bathing Rooms												
4	Boys' Toilet Room	1		Overall Access	Toilet Room

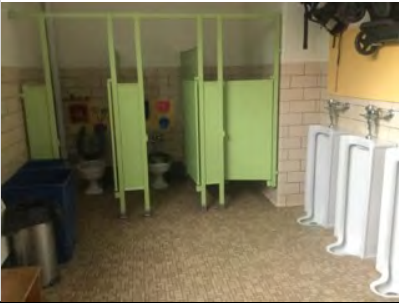
Accessible plumbing fixtures or stalls not provided		Provide one accessible wheelchair compartment.	1	3091	\$3091

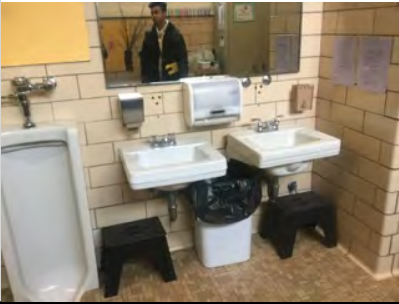
Exposed plumbing underneath Mirror above lavatory w/reflective surface > 31"	- 44"	Insulate or otherwise configure pipes to prevent contact, for at least one lavatory. Lower mirror so that the bottom surface is at 31" above finished floor.	1	174	\$174
Additional Access												
6	Classroom 3	1		Sinks for Children's Use	Classroom

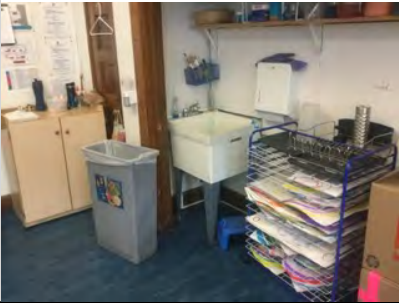
Rim or counter at sink > 30" Knee or toe clearance not provided	33" -	Provide a new sink with the front of the rim or counter no higher than 30" and ensure the sink has 25" high min. 30" wide min. knee and toe clearance positioned for a forward approach.	1	1,547	\$1547
Additional Access												
7	Corridor Near Classroom 3	1		Drinking Fountains	Low

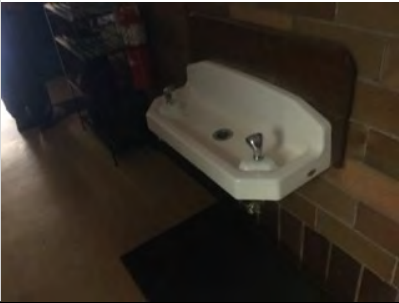
No drinking fountain provided for standing users	29"	Install a Hi-Lo drinking fountain.	1	2,108	\$2108

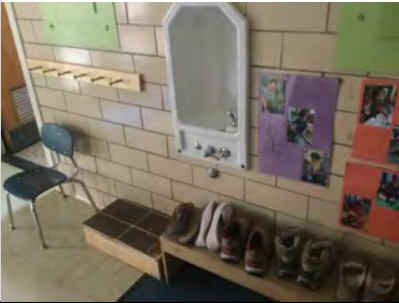
Additional Access												
8	Drinking Fountain Near Toilet Rooms	1		Drinking Fountains	Low

No drinking fountain provided for standing users		Provide an additional drinking fountain for standing users.	1	2,014	\$2014

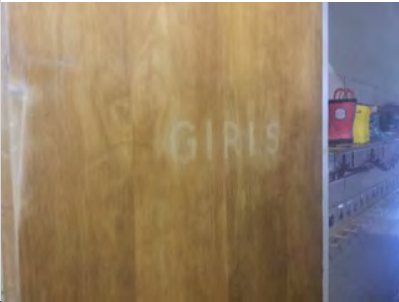
Raised characters not provided Braille not provided International Symbol of Acc. not compliant		Provide text with raised characters duplicated in braille. Locate sign alongside the door on the latch side. After the toilet room is brought into compliance, ensure that the sign contains the International Symbol of Accessibility.	1	116	\$116
Toilet & Bathing Rooms												
10	Girls' Toilet Room	1		Overall Access	N/A

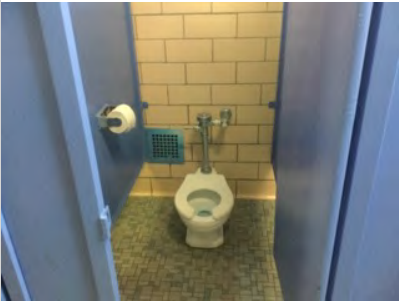
Accessible plumbing fixtures or stalls not provided		Provide one accessible wheelchair compartment.	1	3,091	\$3091
Toilet Rooms for Children												
11	Girls' Toilet Room	1		Lavatory	N/A

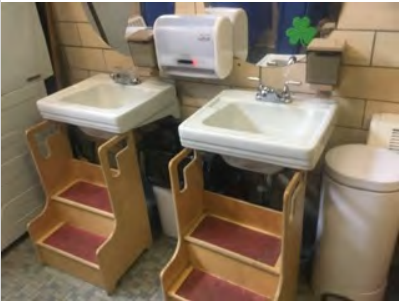
Exposed plumbing underneath Mirror above lavatory w/reflective surface > 31"	- 35"	Insulate or otherwise configure pipes to prevent contact, for at least one lavatory. Lower mirror so that the bottom surface is at 31" above finished floor.	1	174	\$174

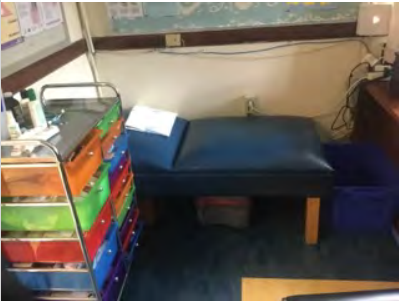
Best Practice												
12	Nurse's Office	1

Best Practice: Provide an adjustable height medical exam table.	1	-	\$0

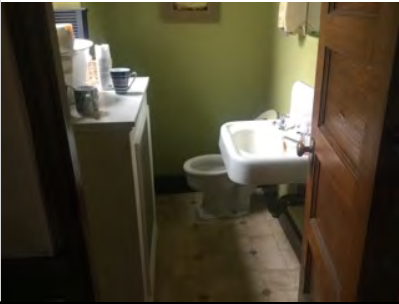
Turning space not provided Accessible plumbing fixtures or stalls not provided		Provide an accessible single-user toilet room.	1	12,302	\$12302
Access to Goods and Services												
14	Offices	1		Doors, Doorways, & Gates	Office

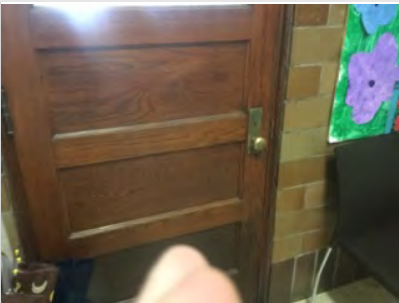
Hardware not operable with a closed fist		Provide hardware that can be operable with one hand and not require tight grasping, pinching, or twisting of the wrist.	2	242	\$484
Approach and Entrance												
15	Preschool Entrance (West)	1		Emergency Exit	N/A

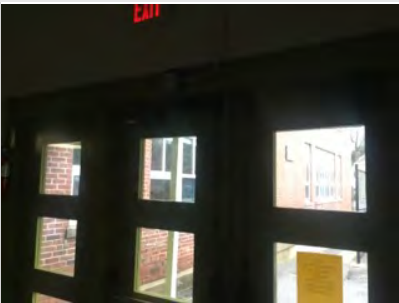
Tactile exit sign not provided International Symbol of Acc. not provided		Provide a tactile exit sign with raised characters and braille at exit doors. Mount signs between 48"- 60" above finished floor located on the latch side of the door. After the exit is made compliant, provide an illuminated sign with the International Symbol of Accessibility.	2	116	\$232
